Manhole Inspection Summary

Manhole # S43K__040MH

Insp Date: **6/3/08 3:33 PM**

Location Address: **700 s bond st**

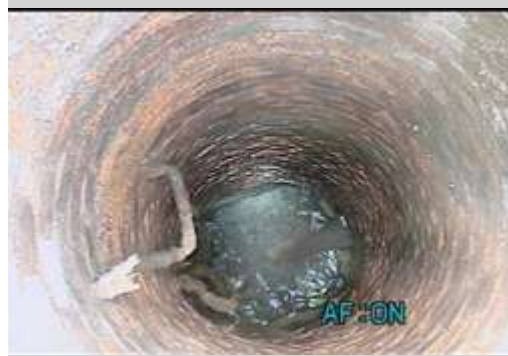
Top View

top view & steps

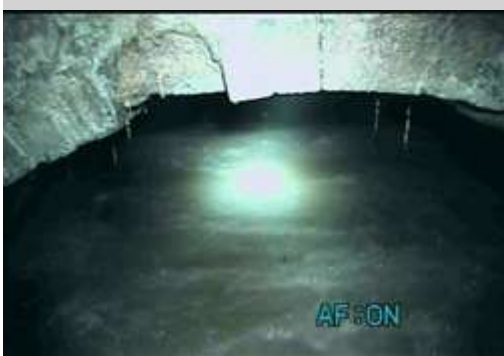
Defect 3

Condition: ☐ Sound ☐ Cracked ☐ Root Intrusion ☒ **Loose Brick** ☐ Deteriorated

barrel loose bricks/missing bricks

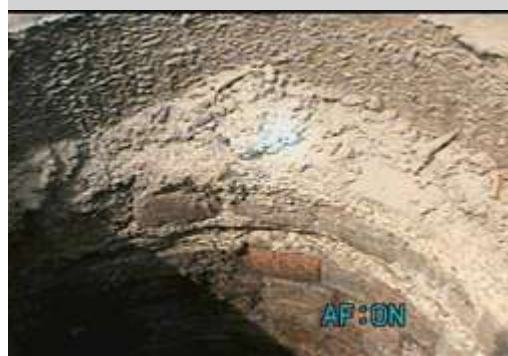
Defect 1

Offset: **2** (in.)

frame offset

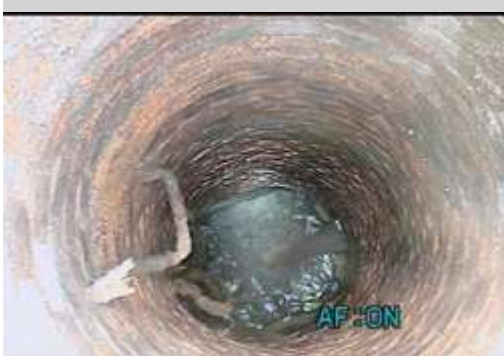
Defect 2

Count: **7** Missing: **1** ☒ **Corroded**

☒ **Evidence Of Surcharge**

Depth: **11.** (ft.) ☐ Active Surcharge Present

missing/corroded steps, surcharge evidence
